Attachment E

Location and Type of NESC Violation

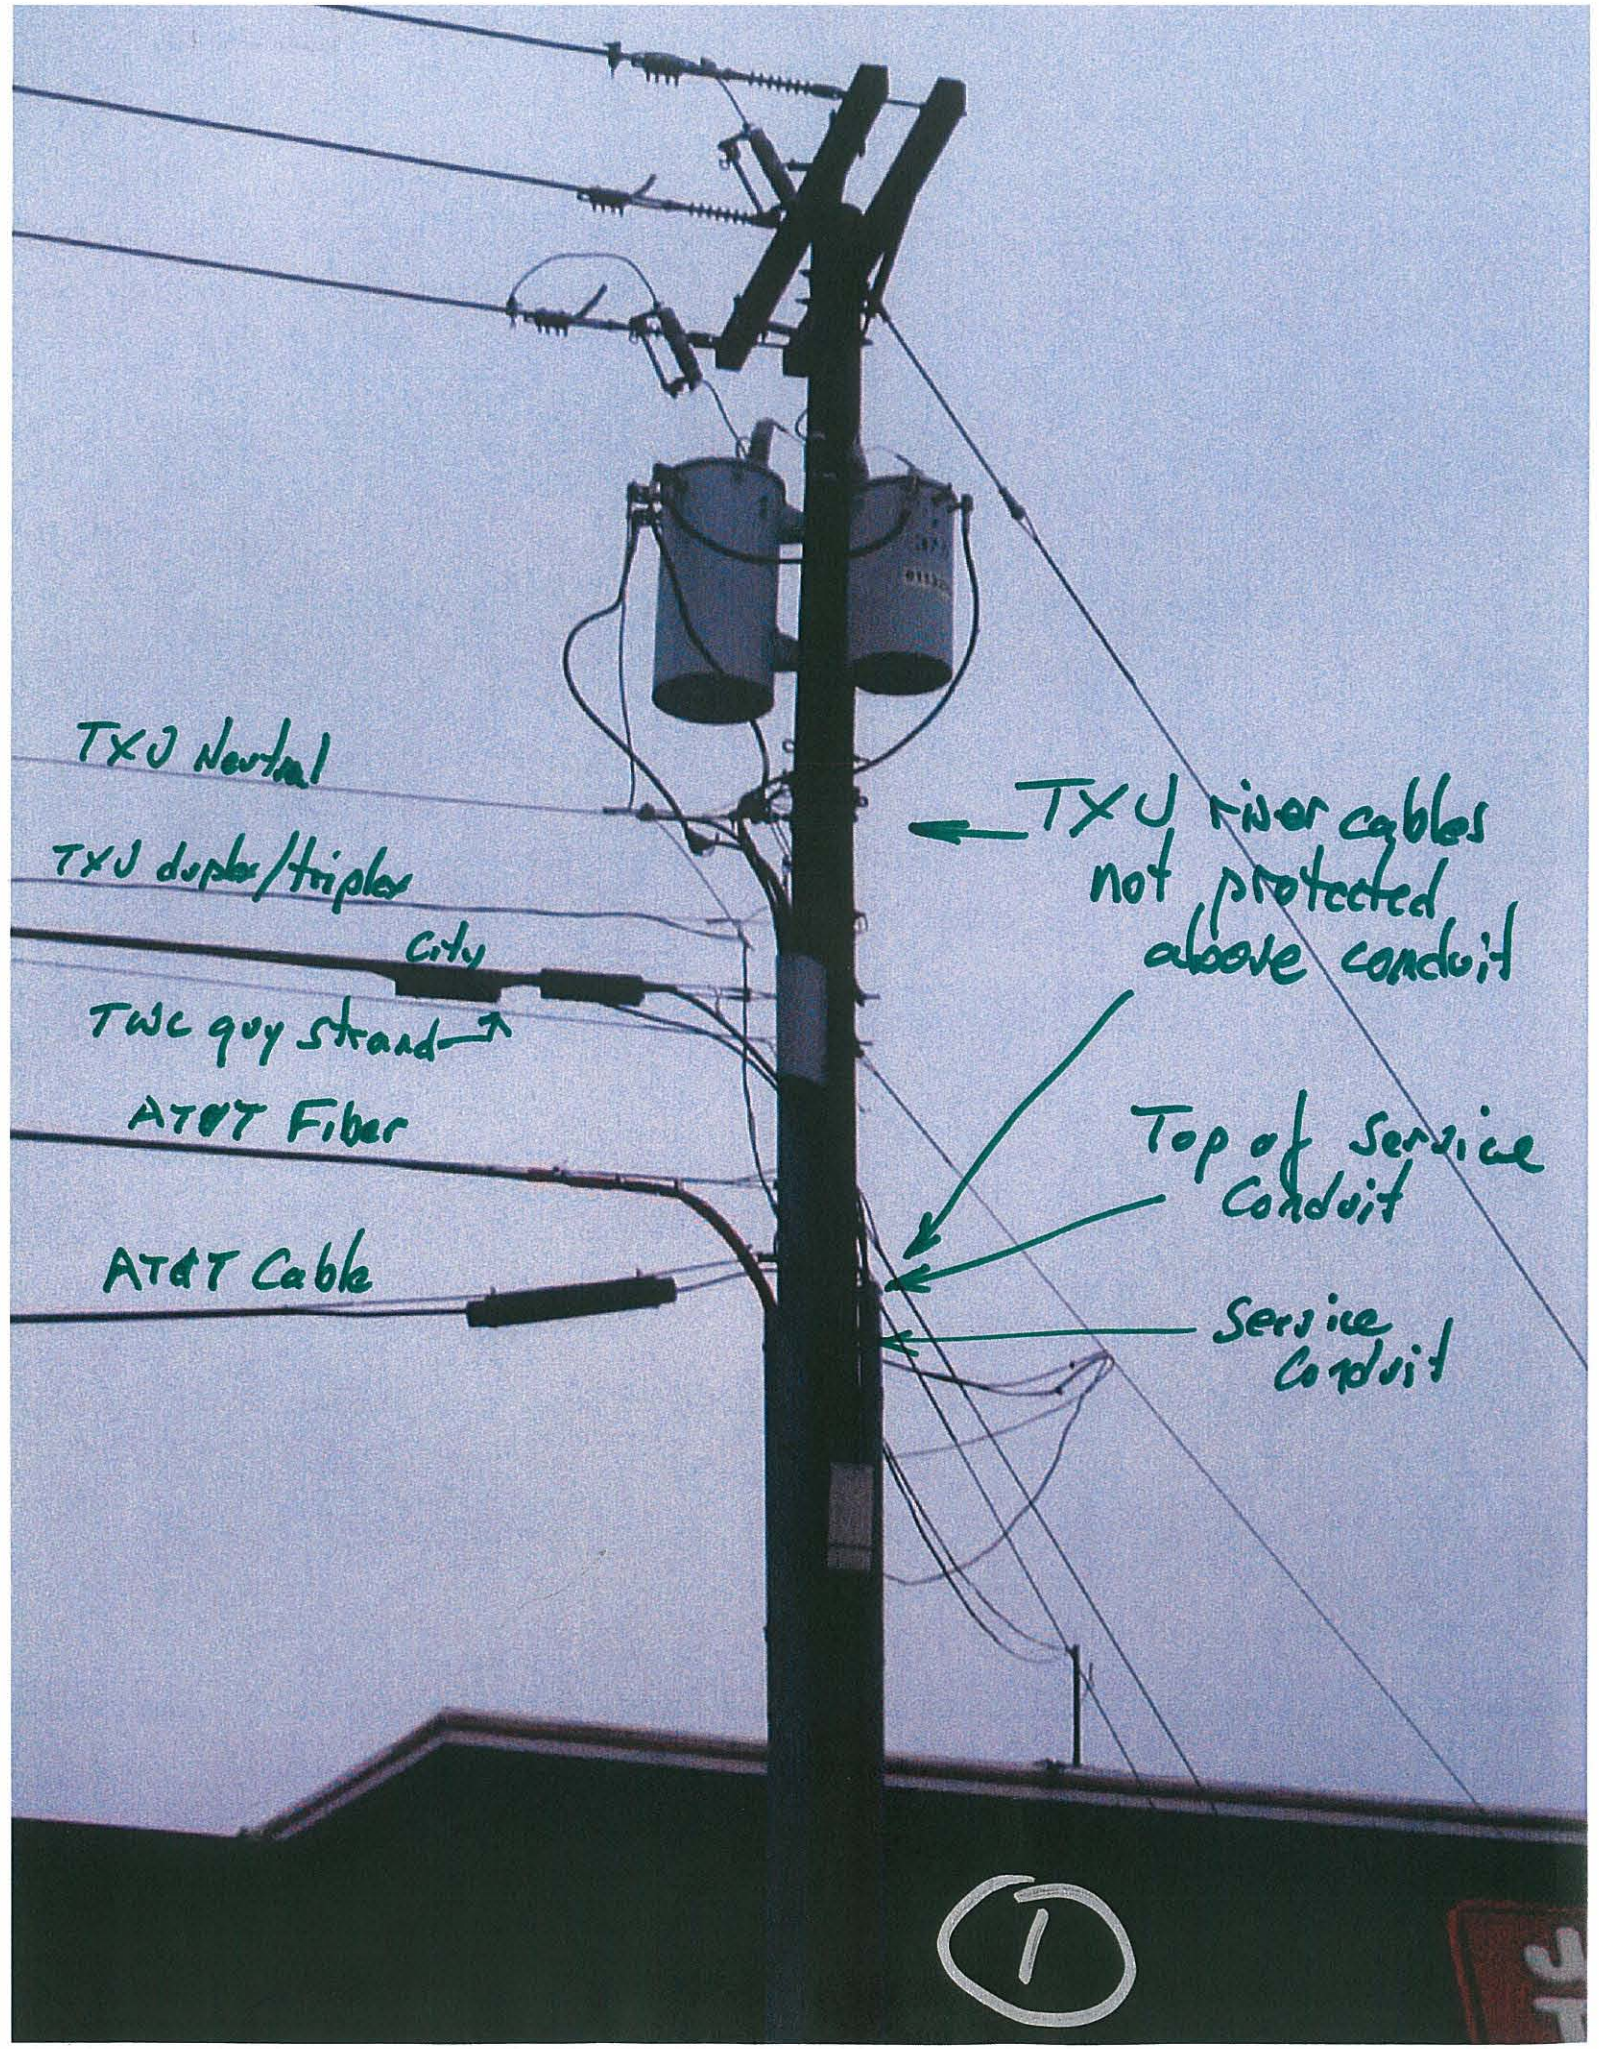
Photo 1 – First pole south of Division:

TXU triplex pole attachment:

TXU-TWC, TXU-probable.

TXU-City, cause unknown.

TXU unprotected riser:

TXU-TWC, TXU-caused.

TXU-AT&T, TXU-caused.

TXU-City, TXU-caused.

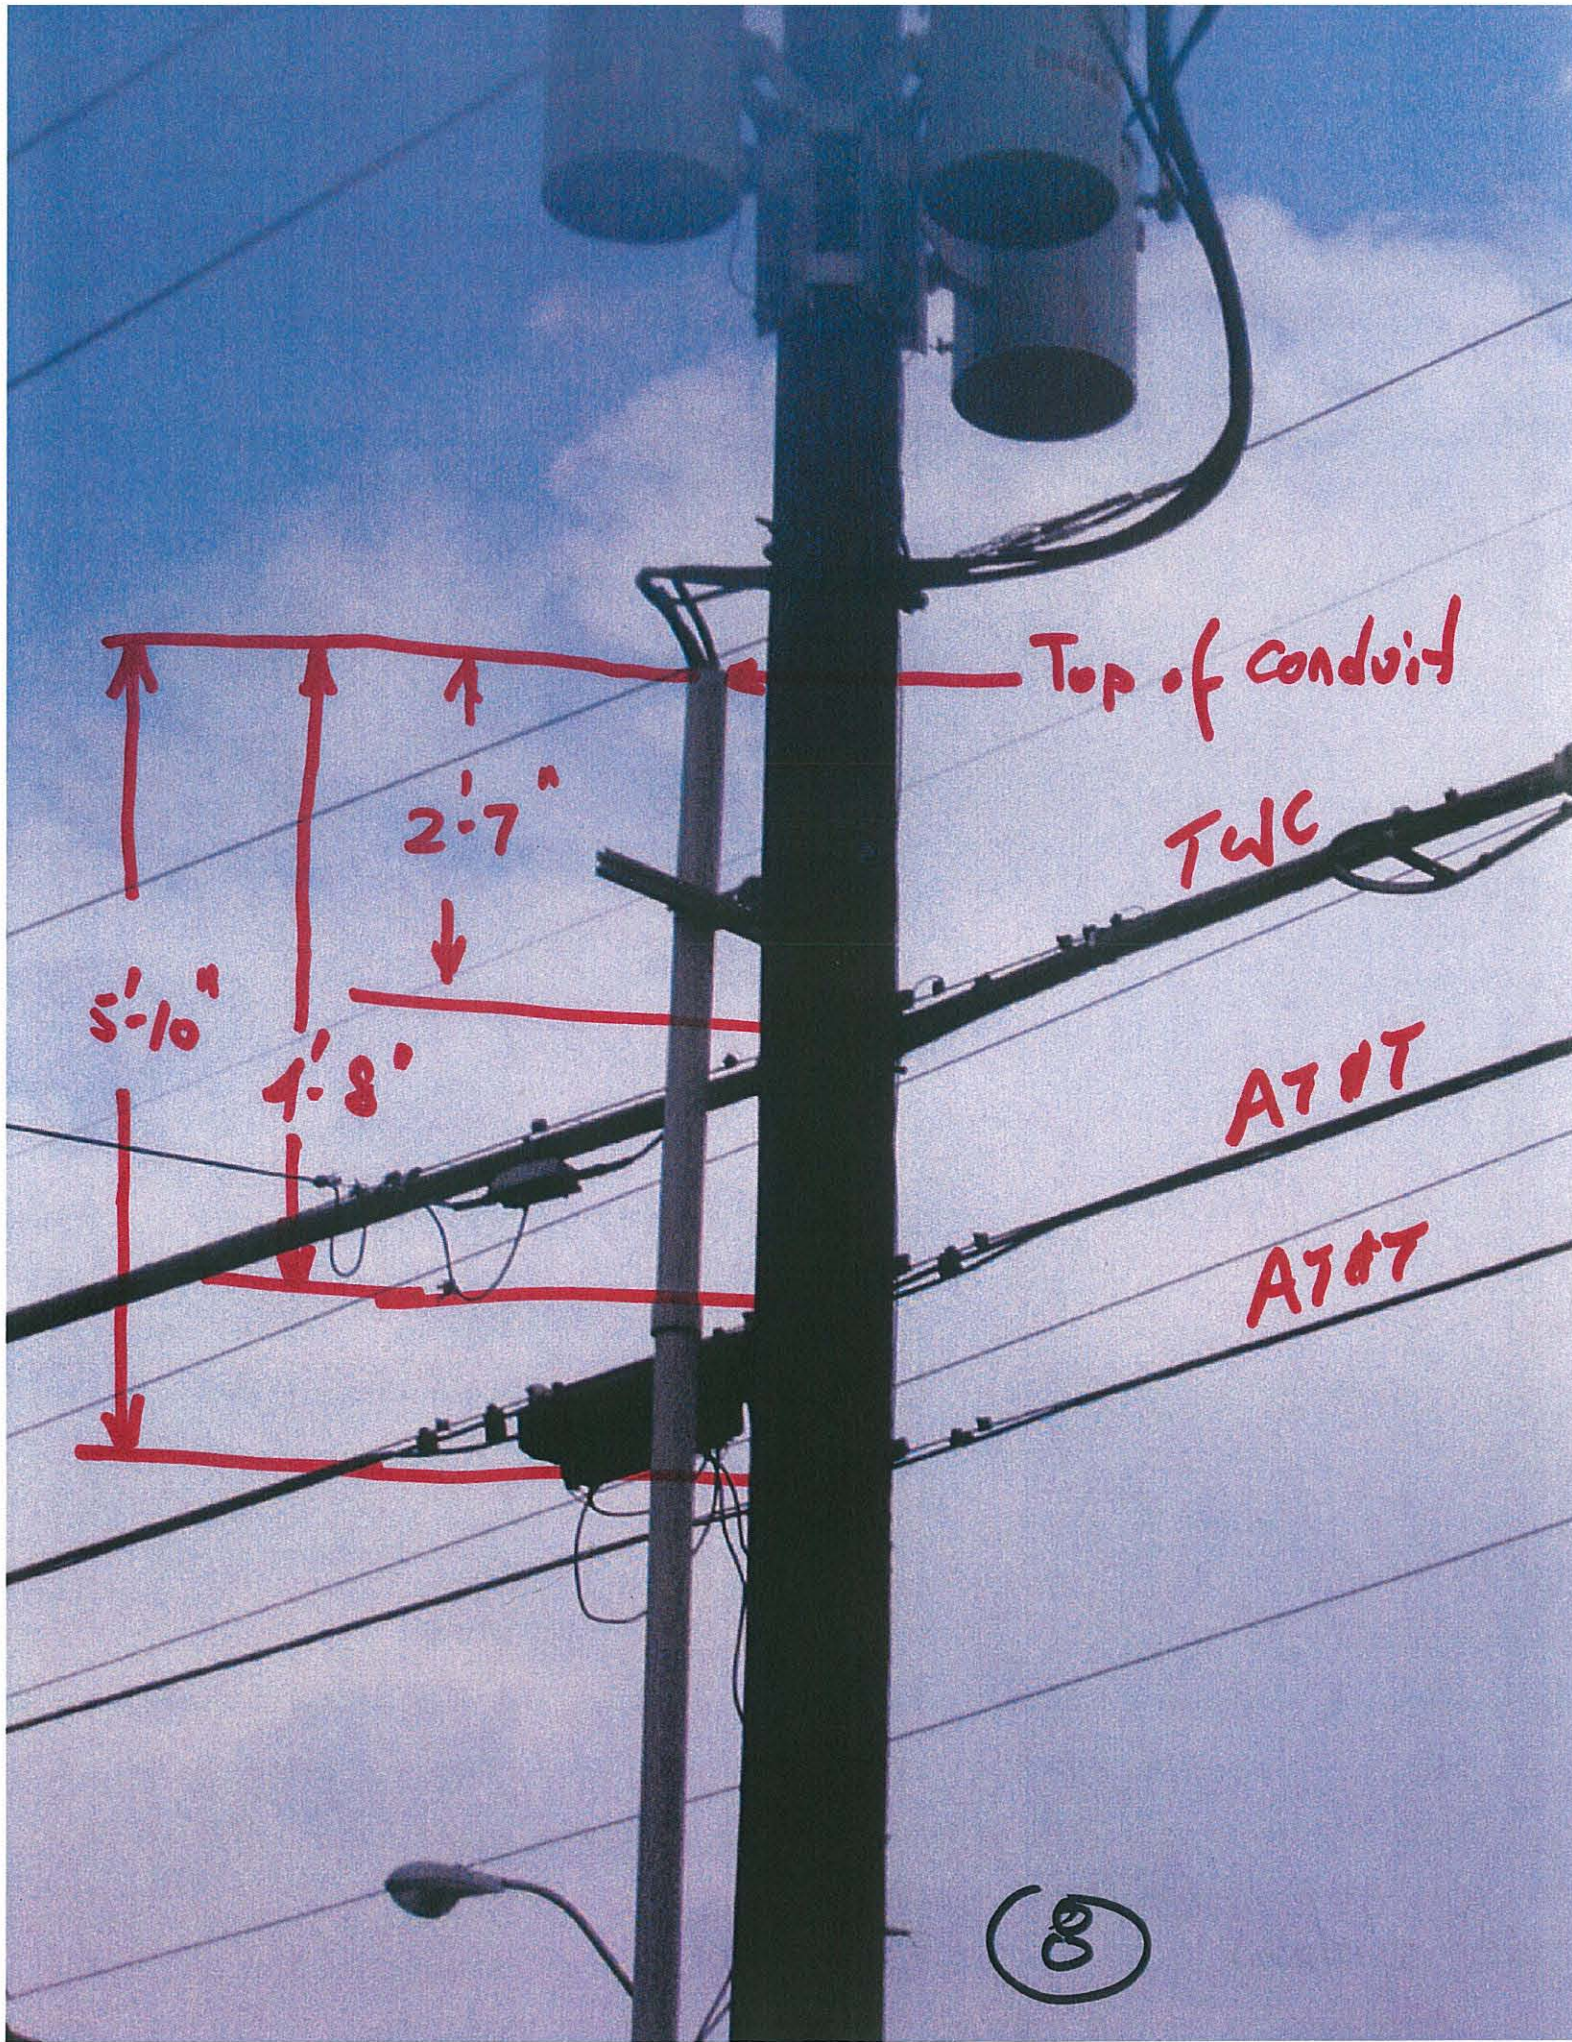
Photo 8 – Second pole north of Finley. This is another TXU unprotected riser, new conduit, TXU-TWC, TXU-caused.

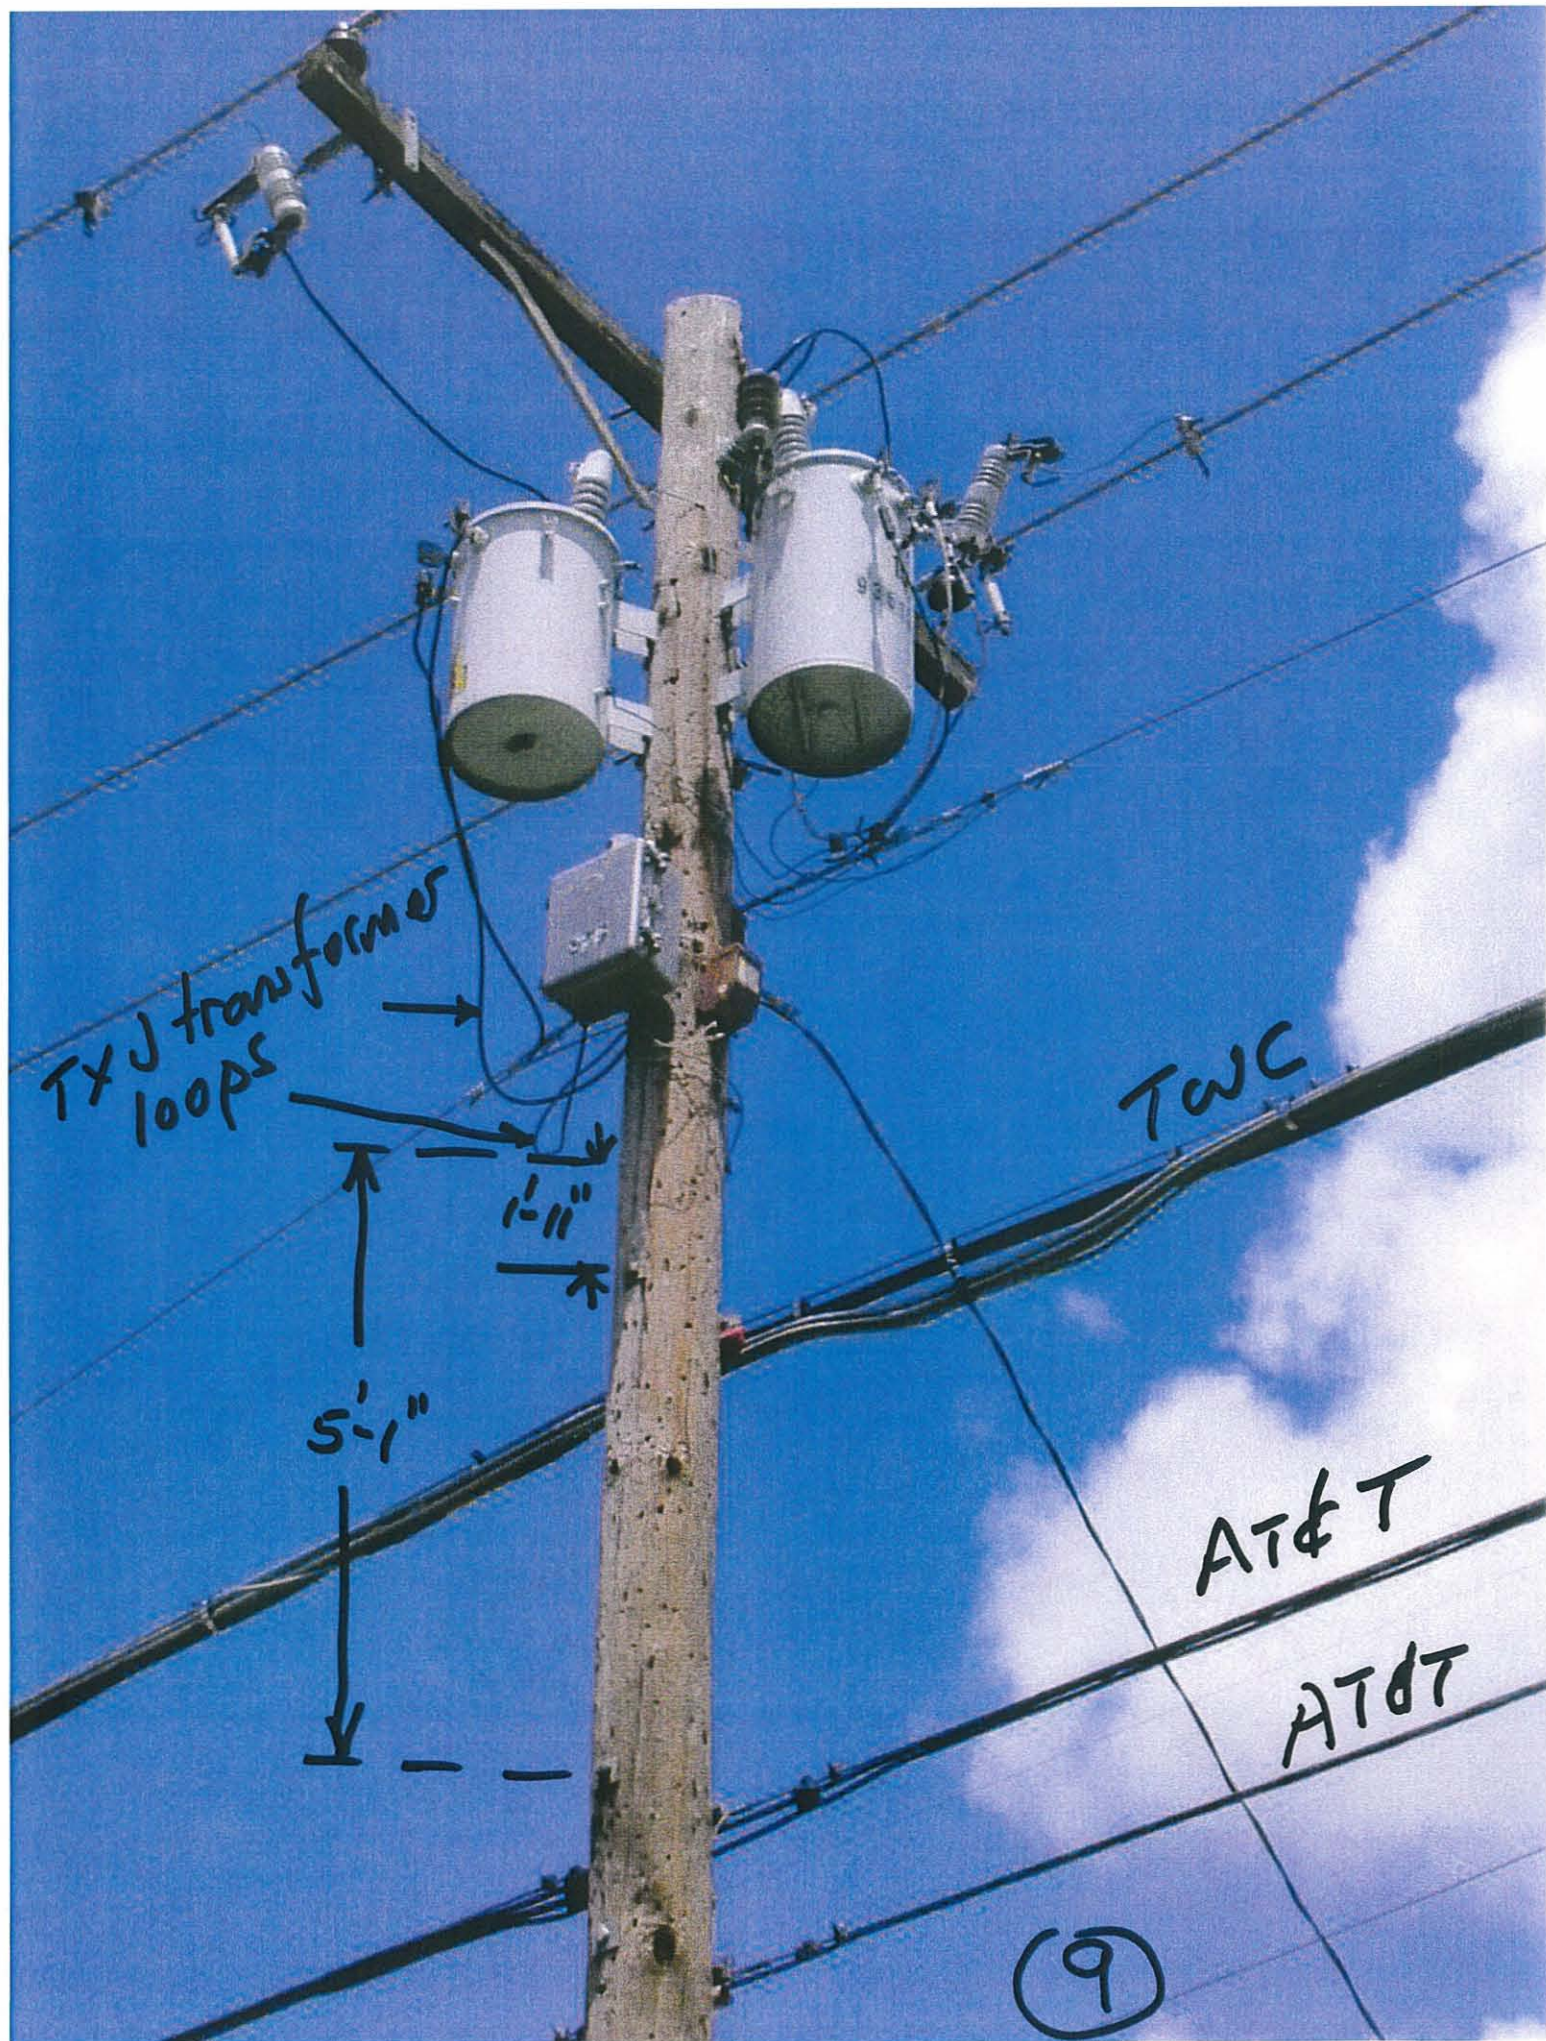
(9)

Photo 9 – Third pole north of Finley. This is excessive sag in TXU transformer leads feeding control box, TXU-TWC, TXU-probable.

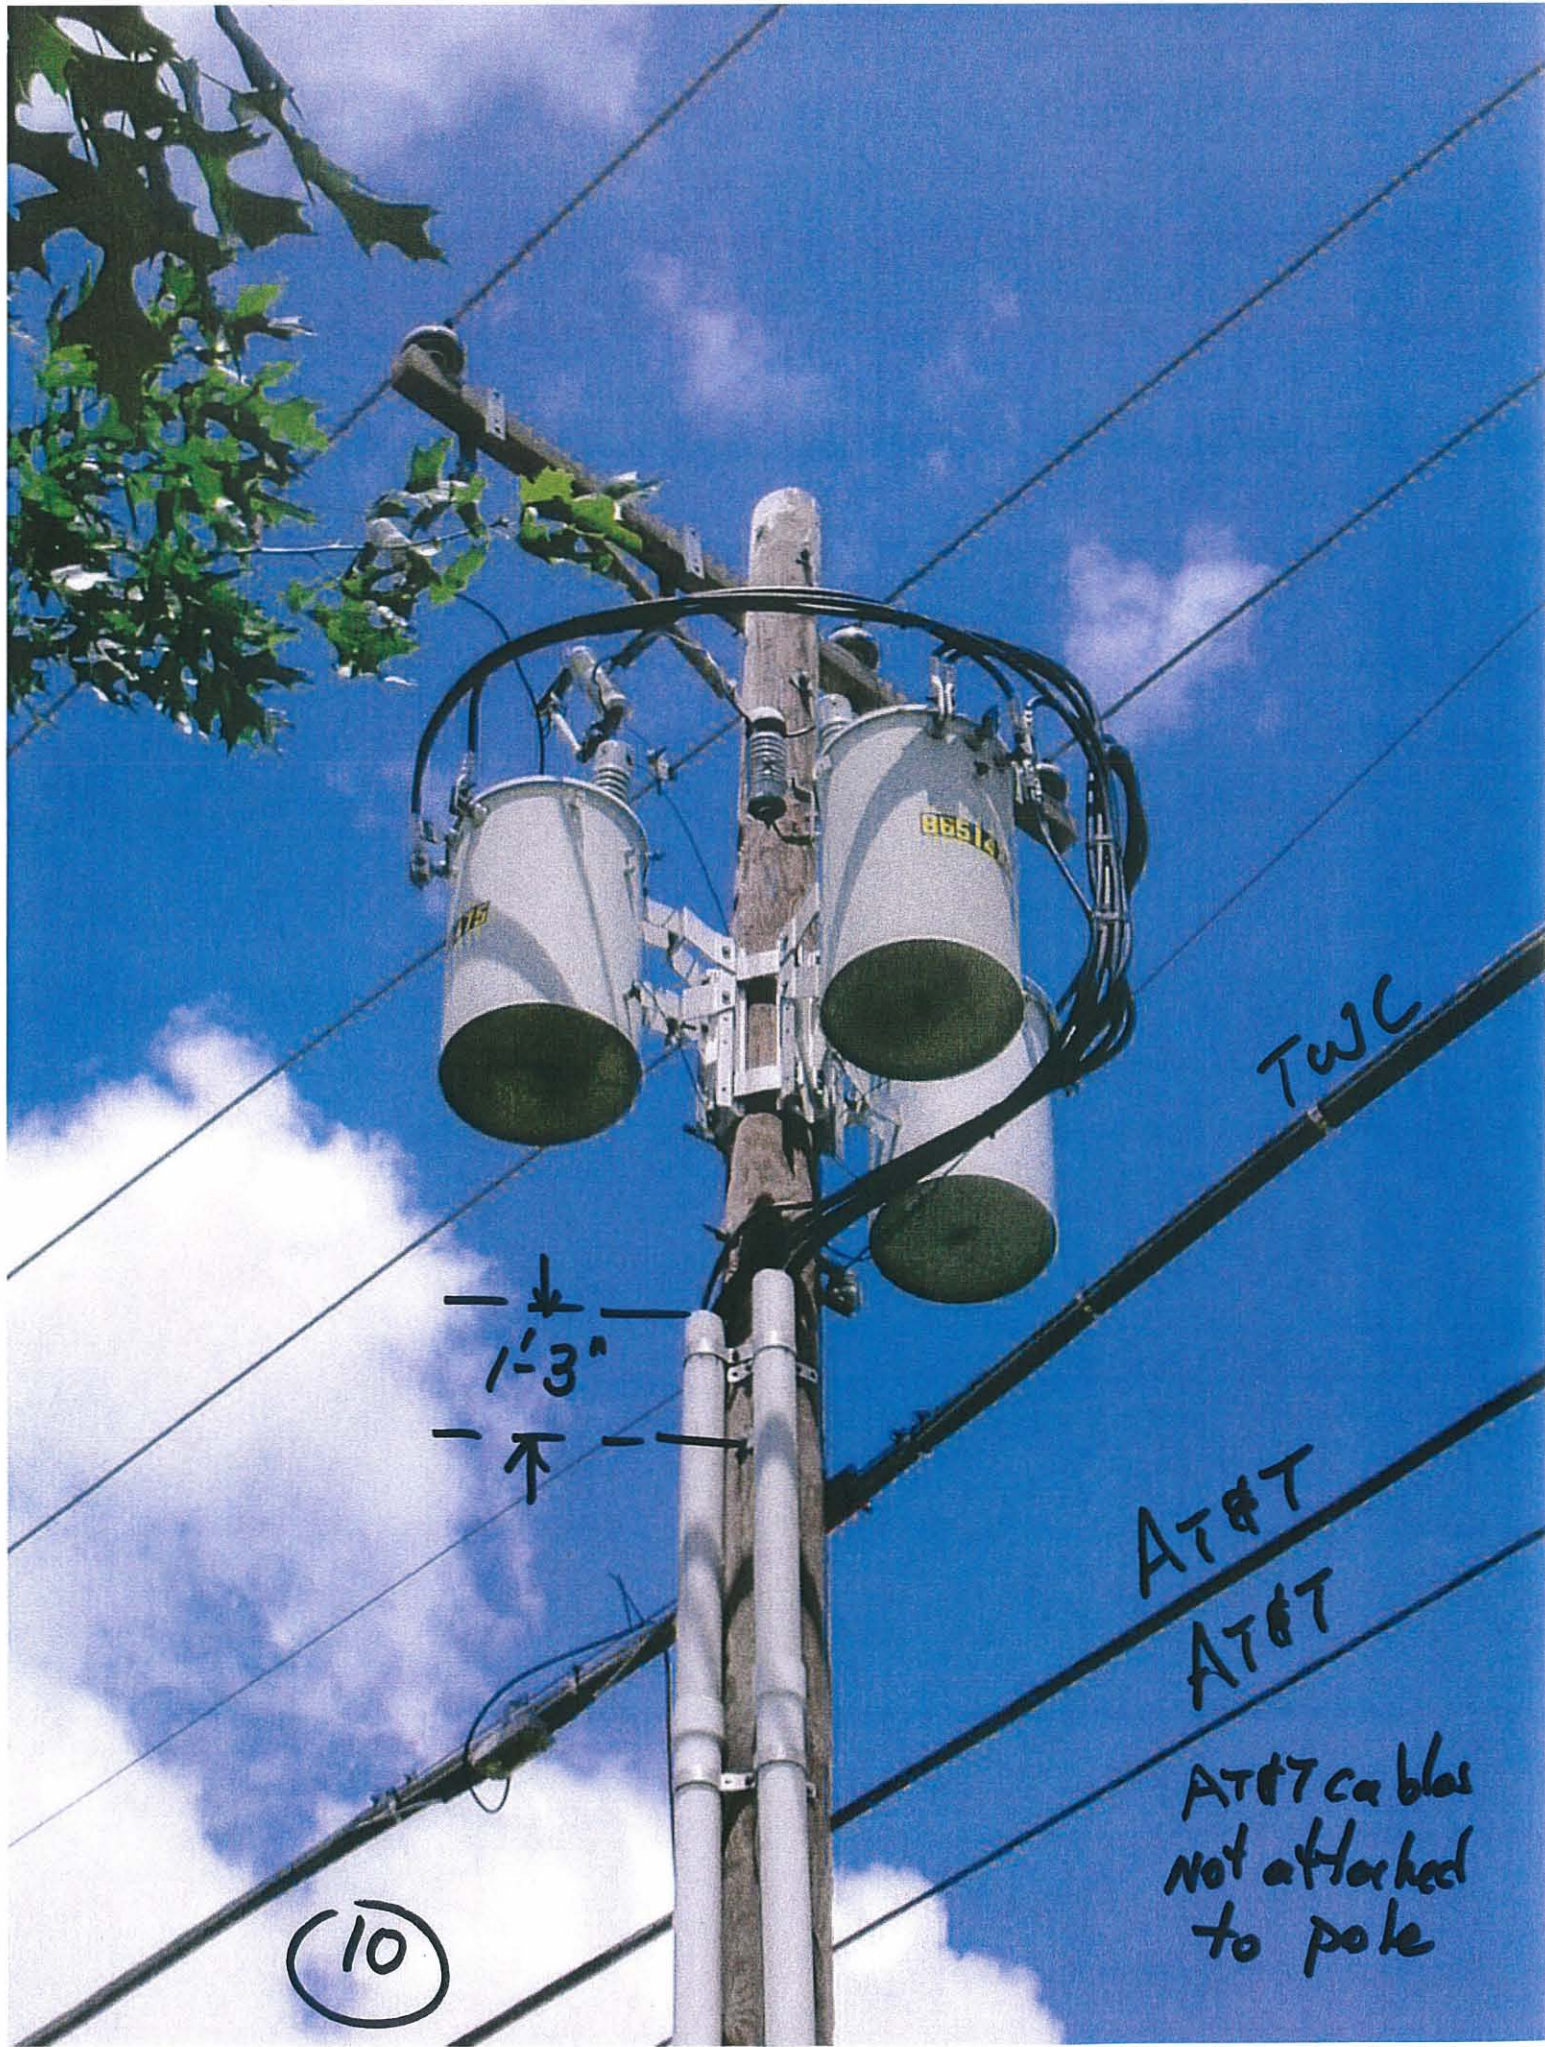
(10)

Photo 10 – Fourth pole north of Finley. These are TXU unprotected risers, new conduits, TXU-TWC, TXU-caused.

AT&T cables
not attached
to pole
